MERRIMACK RIVER BASIN
SALEM, NEW HAMPSHIRE

MILLVILLE RESERVOIR DAM

N H 00030
NHWRB 209.08

PHASE I INSPECTION REPORT
NATIONAL DAM INSPECTION PROGRAM

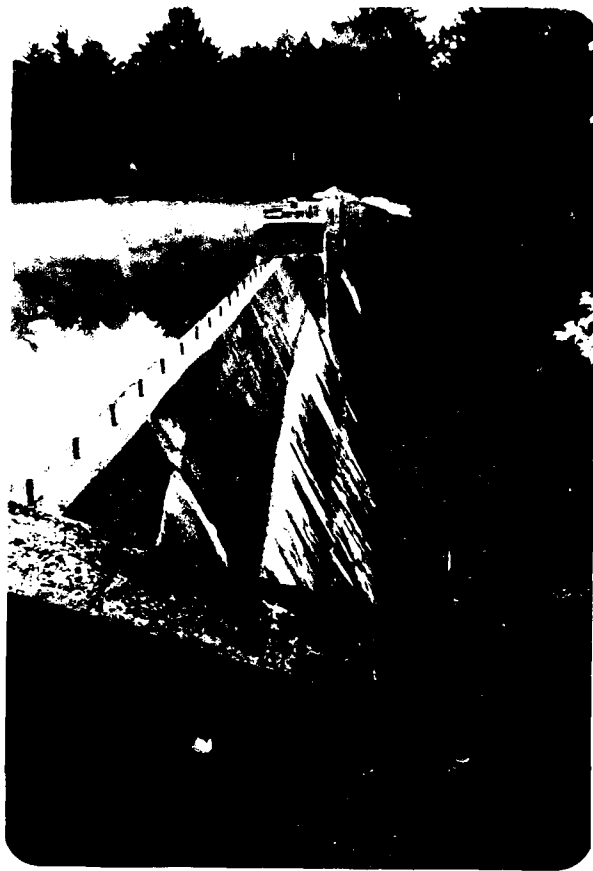
Overview from right endwall
